Heritage Conservation, LLC

Conservation Report:

35 Star US Swallowtail Guidon

Carolina Collectors

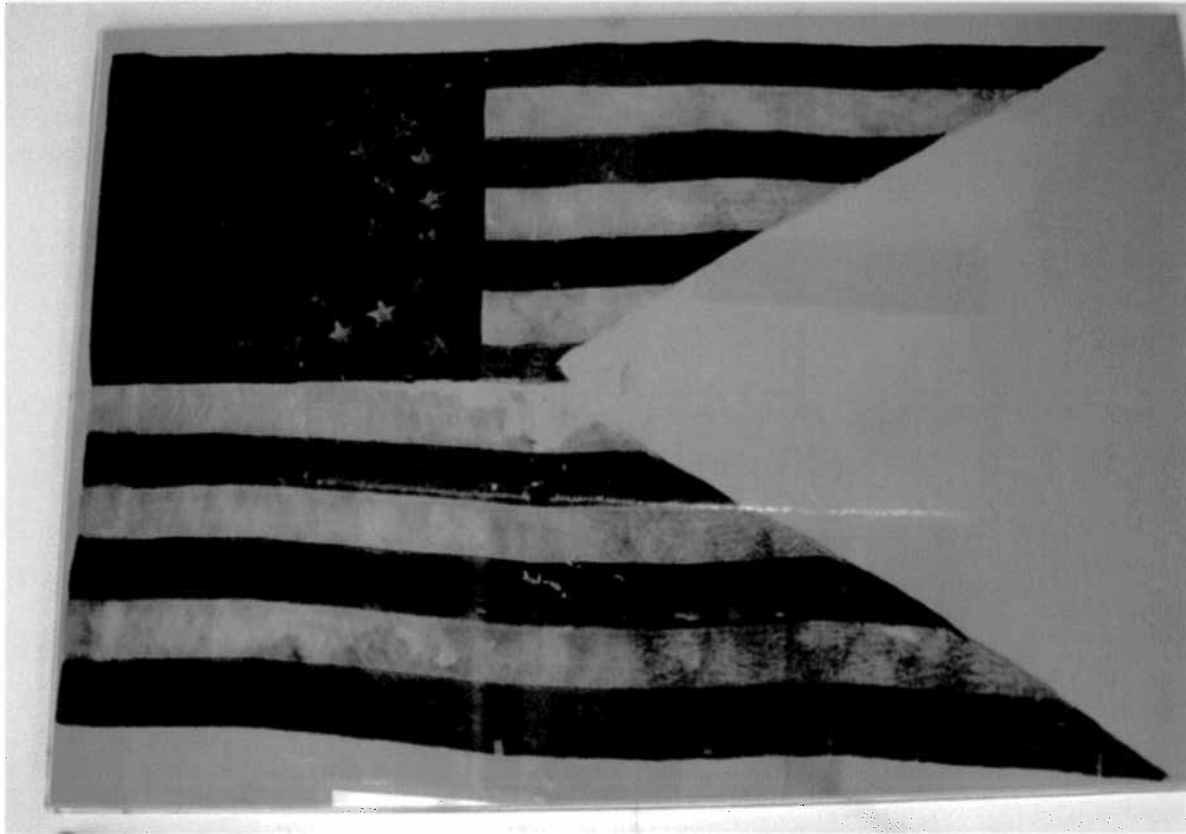
Guidon before removal from the TCW mount, fractured at the center

According to a label affixed to the frame back, the flag was previously treated and framed by "Textile Conservation Workshop." The reason for the current treatment is a failure of the pressure mount by TCW. Upon inspection, the 1/8" thick acrylic glazing was too flexible and there was no pressure on the center of the flag, with approximately ¼" of gap between the acrylic and the flag. The lower half of the flag separated at the line of the canton and dropped, scissor fashion, about two inches. The resulting tear did considerable damage to the center white stripe, with numerous fragments dislodged about the frame or lost.

Upon removal from the pressure mount, it was discovered that most of the stripes had been backed by stabilizing silk fabric coated with an unknown adhesive, as would be appropriate for a deteriorating, fragile flag. For some inexplicable reason, however, the center white bar running below the canton and the second white bar from the top were not backed/stabilized. This is where the tear occurred.

Additionally, no batting was used on the back board to create a cushioning tension. All of these oversights led to the failed pressure mount resulting in the described flag damage.

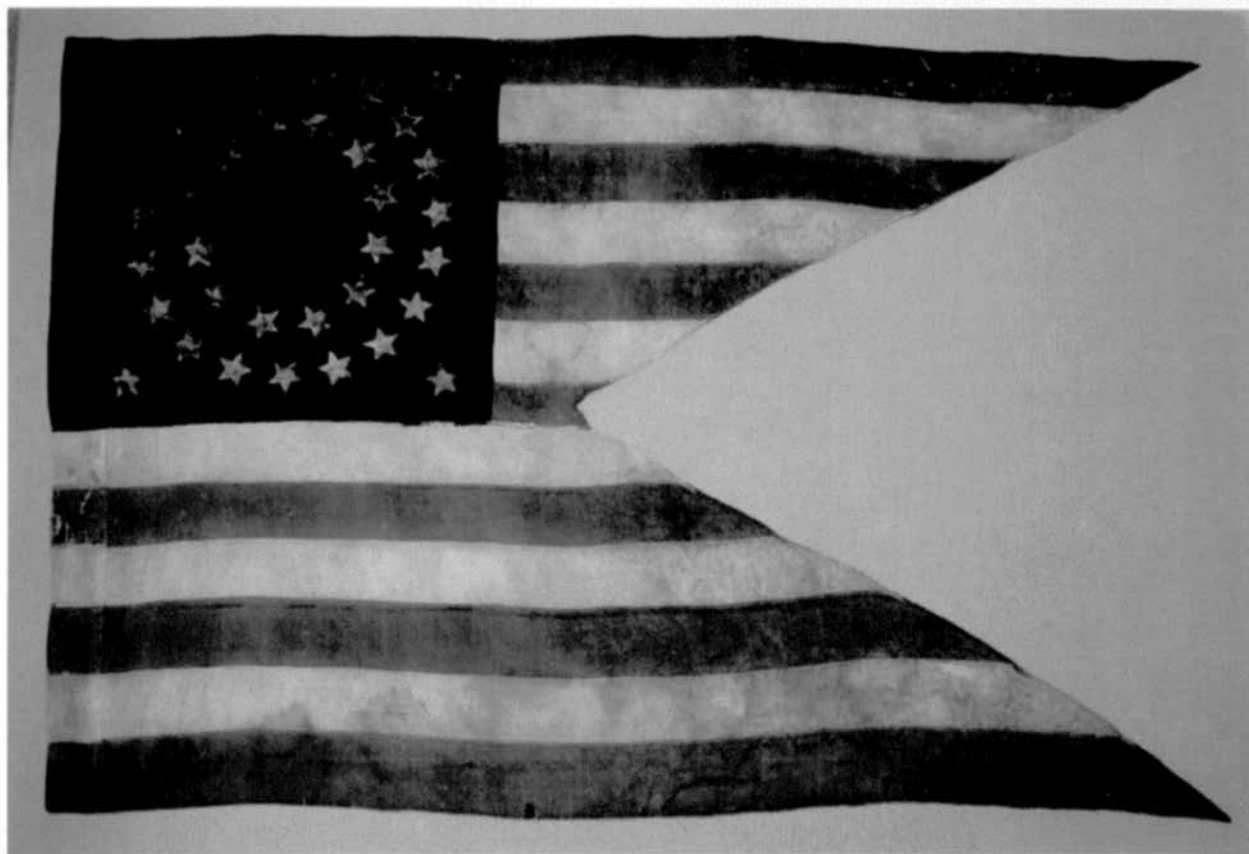
Guidon after treatment

Using the stencil, silk organza backing material of an appropriate color was cut out for each stripe and coated front and back with Lascaux 498, a thermoplastic polymer. Each backing piece, including one for the canton, was placed on its flag counterpart and the entire flag was sealed to the backing. Loose fragments were replaced where possible.

The flag was replaced upon the backing mount and heat sealed to it. The stars on the obverse side were consolidated with Lascaux Hydrosealer 750 to preserve them and prevent paint flaking. The flag was then vacuumed and the acrylic cover was replaced.
