Heritage Conservation, LLC

Conservation Report:

35 Star US Swallowtail Guidon

Carolina Collectors

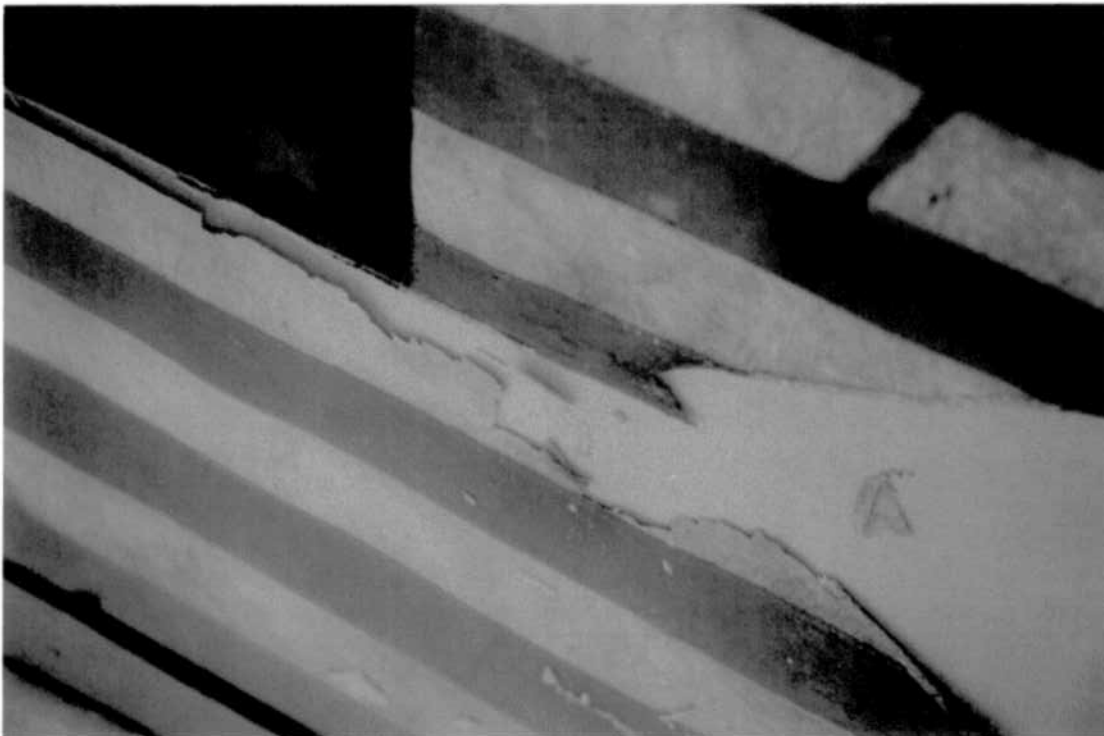
Guidon before removal from the TCW mount, fractured at the center

According to a label affixed to the frame back, the flag was previously treated and framed by "Textile Conservation Workshop." The reason for the current treatment is a failure of the pressure mount by TCW. Upon inspection, the 1/8" thick acrylic glazing was too flexible and there was no pressure on the center of the flag, with approximately ¼" of gap between the acrylic and the flag. The lower half of the flag separated at the line of the canton and dropped, scissor fashion, about two inches. The resulting tear did considerable damage to the center white stripe, with numerous fragments dislodged about the frame or lost.

Upon removal from the pressure mount, it was discovered that most of the stripes had been backed by stabilizing silk fabric coated with an unknown adhesive, as would be appropriate for a deteriorating, fragile flag. For some inexplicable reason, however, the center white bar running below the canton and the second white bar from the top were not backed/stabilized. This is where the tear occurred.

Additionally, no batting was used on the back board to create a cushioning tension. All of these oversights led to the failed pressure mount resulting in the described flag damage.

Client wishes to reuse the existing pressure mount for economical reasons. Given that this mount alone will not provide sufficient pressure on the flag center, a complete re-stabilization is recommended to bond the flag to the mounting board. The combination of bonding the flag to the board with a thermoplastic polymer and a pressure mount will be adequate stabilization.

The previous backing was heat tested and was found no longer thermo active, thus necessitating a new backing. This previous backing could not be removed without damaging the flag, so a new backing was applied to the old.

Using the stencil, silk organza backing material of an appropriate color was cut out for each stripe and coated front and back with Lascaux 498, a thermoplastic polymer. Each backing piece, including one for the canton, was placed on its flag counterpart and the entire flag was sealed to the backing. Loose fragments were replaced where possible.

The flag was replaced upon the backing mount and heat sealed to it. The stars on the obverse side were consolidated with Lascaux Hydrosealer 750 to preserve them and prevent paint flaking. The flag was then vacuumed and the acrylic cover was replaced.

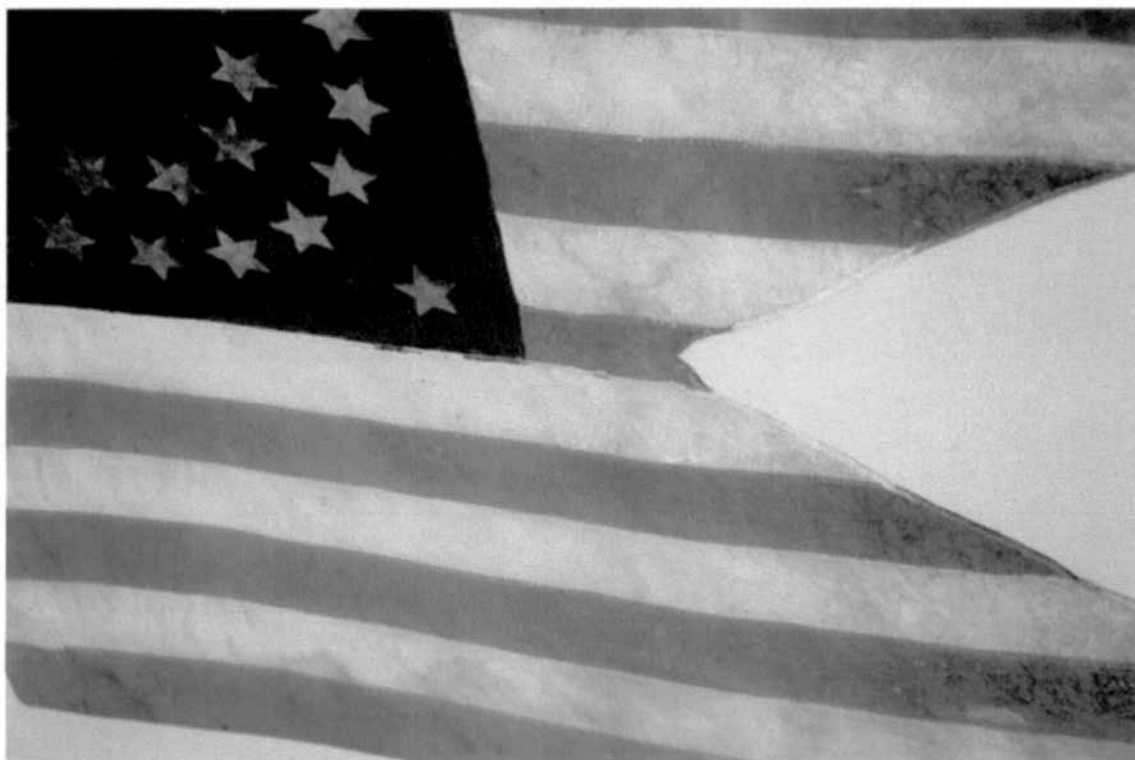
Guidon after treatment
